Fatal Incident Involving an In-Plant Railroad Conductor

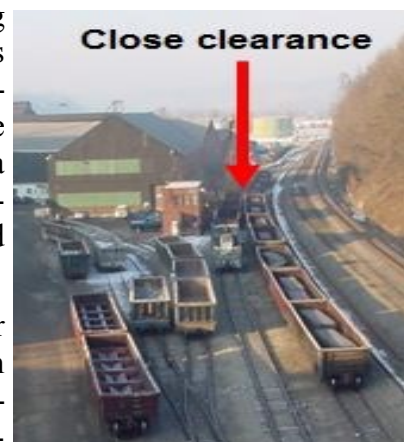
A USW member was fatally injured when he was caught in-between the railcar he was riding and a stationary railcar on the adjacent track on the night shift with snow squalls and poor lighting in the area. The conductor was riding on the stirrup/ladder assembly on the northwest side of the front gondola car of a train being pushed to a car storage area. The conductor, following the Safe Operating Procedure that required rail personnel to not ride on the south side of the car to avoid the “pinch point” of the scale house. For that reason, he was riding on the northwest side of the moving car (opposite from the scale house). Unbeknownst to him and the locomotive engineer, a supervisor had directed the previous shift to park a train of gondola cars on a set of adjacent tracks to the north to save time. That train was made up of non-standard size cars (wider than usual) and was parked in the “foul” (area within four feet of the nearest rail of a railroad track) as directed and stated by the supervisor to his crew. This information was not communicated to the on-coming crew. Non-standard cars have not been stored on the adjacent track in the past due to their wider size, but the supervisor thought they would be able to get ahead of production by doing this.

As the train was in motion, the clearance between the moving train and the stationary railcars narrowed and the conductor was caught in-between the pinch-point between the cars of the two different trains. When the front car of the moving train passed the scale house, the locomotive engineer saw what he believed was a stop signal from the conductor. The engineer stopped the train, dismounted the engine. Eventually he and the shift supervisor found the fatally injured conductor pinned between the railcars.

The conductor commonly rides the front side ladder of the railcar to ensure the rails are free of obstructions. The crew had ridden through this area before with railcars in the area, but not with non-standard cars on the adjacent track. The crew had also been downsized and was now operating as a two person crew instead of three.

- Eliminate pinch-point areas by applying the Hierarchy of Controls and spacing the tracks further apart.
- Form a labor-management railroad safety sub-committee to evaluate rail yard lighting, potential and permanent pinch-point areas and develop recommendations for improvements/corrections.

- Evaluate rail maps and yards for fixed and/or mobile foul/pinch points. Install safety markers and signs in safe locations.
- Utilize a Management Of Change and Management Of Organizational Change program for process and organizational changes that involves employees and their representatives. Include changes such as downsizing. If the proposed change is not safe, the change must not be made.

- Improve communication methods between shifts, conductors and locomotive engineers.
- Employee training, retraining and evaluations must include job transfers, even if the worker had previously held the job classification.

- Provide all hourly and salary employees with a Right-To-Act process and annual retraining. All hourly and salary employees must have a procedure and process to report hazards, stop unsafe/unhealthy jobs/tasks and shutdown any process without the fear of retaliation.
