Fatal Incident Involving a Paper Machine's Secondary Arm and Reel Rail

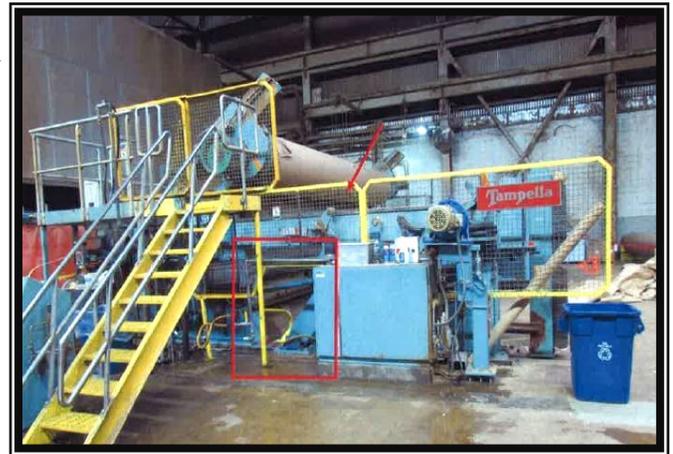
A USW member and “Quality Paper Tester” at a paper mill was fatally injured when he was caught in between the unguarded area of the pneumatic secondary arm and the reel rail frame of the paper machine while trying to get a broken sheet of paper back on the reel. The worker had been at the paper machine waiting to take a sample of paper for testing.

The reel had turned up a new roll and the secondary arm had kicked the spool out. The next roll of paper was started and the paper sheet completely snapped off. The “broke” paper went downward through the floor opening and onto the conveyor that carries broken paper to the hydropulper. The worker began using a compressed air hose to blow the broken paper sheet back up onto the spool when he was caught-in the paper machine.

Although this was not the worker’s normal job duty, it was a common practice for workers to go under the machine guarding as the lower portion of the guard is approximately three-feet off the floor with approximately a four-foot cutout by design. The four foot cutout in the guarding was designed so workers could perform this task. Having access inside the framework (behind the machine guarding) provided a better angle to use a compressed air hose to blow the broken sheet of paper back onto the spool.

- Conduct a hazard analysis with worker participation that focuses on the relationship between the workers and the task, the tools (or lack of) and the environment. Consider the entire machine operation production process, the machine modes of operation, individual activities associated with the operation, servicing and maintenance activities. The results from the analysis may then be used as a basis to design machine safeguarding, energy control program and procedures.

- Install safeguarding that is properly designed, constructed, fitted, securely held in place, not easily defeated, located at an adequate distance from the hazards and does not obstruct the view of the process and hazards.

- Install operator stations and/or cameras to allow operators to view all areas of the machine.
- Develop and document procedures for a manual turn-up with input from the shift crews; update training accordingly.

- Implement a maintenance and inspection system with parts readily available.
- Provide all workers with a Right-To-Act process including, but not limited to: procedures to report hazards; refuse unsafe or unhealthy tasks; and shut down any process without the fear of retaliation. All workers should be trained or retrained annually on the Right-To-Act process.

- Evaluate compressed air showers (blowers) so they are adequate to blow paper over the parent reel to eliminate or reduce extra air valves and hoses.
