## Serious Incident Involving a Chain Wheel Operated Valve

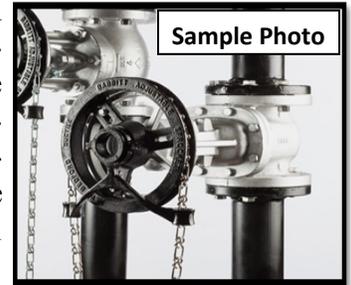
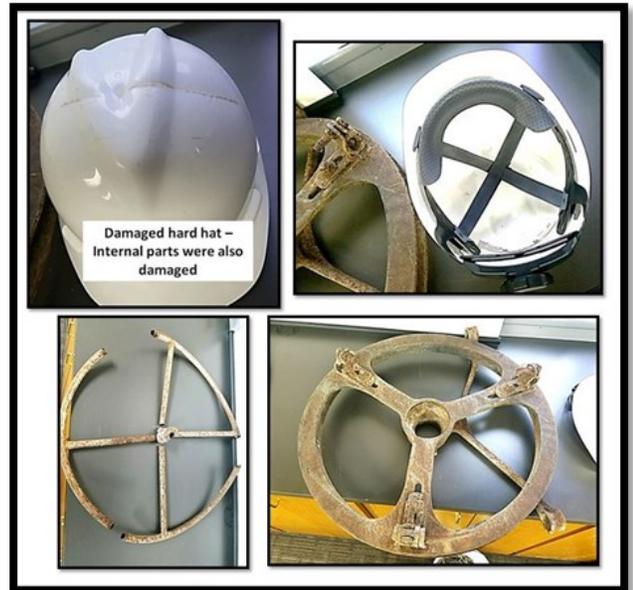
A member received multiple injuries while working with a chain wheel operated valve when the actuator/operator (weighing approximately 60-pounds) on an overhead line broke away striking him on the head. His hard hat lessened the severity of the injury, but he was hospitalized and will continue to miss days away from work. The falling portion of the valve he was locking out was approximately 20-feet above his head. At this time, it is uncertain who manufactured the chain wheel operated valve.

The chain wheel operated valve and PPE involved in this incident are shown in the photographs. The lessons learned and recommendations from this incident are still in progress; however, due to the prevalence of chain wheel operated valves in our workplaces, we are alerting you to the possibility that these devices could separate and fall from the valve handles causing serious injuries.

As we are still learning more around this event, we ask that you assess your workplace(s) of the potential for failures associated with overhead chain wheel operated valves and take appropriate actions, including, but not limited to:

1. Inventory all locations where chain wheel operated valves are located, focusing particularly on those devices located in areas where corrosive conditions may exist.

2. Evaluate whether the metal composition, coatings and other aspects of the chain wheel operated valve's construction are appropriate for the conditions where the equipment is located.

3. Inspect the method used to attach the chain wheels to the valve hand wheels (e.g., determine whether set screws and threaded attachments/fasteners are secure and tight).

4. Review preventative and periodic maintenance procedures for chain wheel operated valves in accordance with the manufacturer's guidelines.
5. Assess the suitability of working surfaces available to employees operating or working on chain wheel operated valves.

6. Where applicable, replace chain wheel operated valves with a different type of valve (such as remote operation) using a Management of Change (MOC) process.

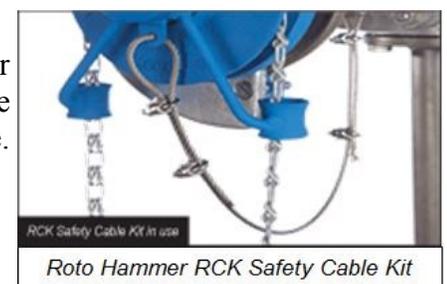
Some manufacturers of chain wheel operated valves offer safety cable kits that provide an extra level of protection in the event a chain wheel becomes detached from an overhead valve. This photo is one example of a chain wheel safety cable.
