**Spring
Failure
on a
Flat Ramp
Telescoping
Gangway
Causes
Severe
Injuries**

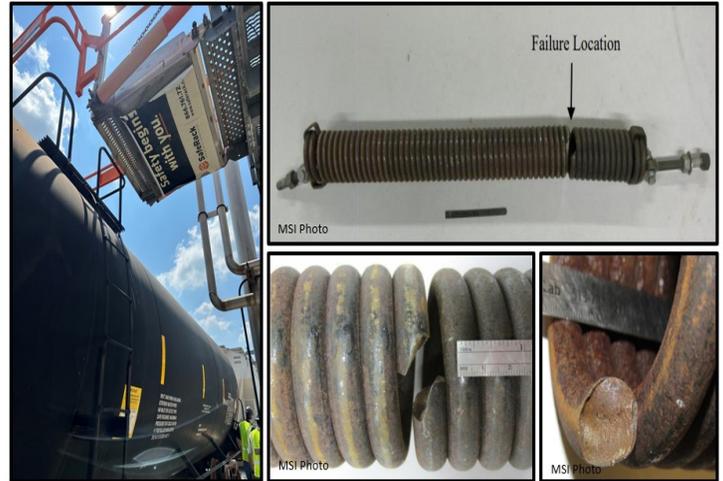
The equipment involved was located at a turpentine unloading platform. It was found to have a crack initiation at the inner surface of the assist spring, and was most likely associated with pitting damage. The fractured surface in the initiation region was oxidized, and contained evidence of beach marks (concentric rings in a fatigue region which resemble tide marks on a beach). These features suggest that the initial mode of failure was fatigue. Corrosion deposits on the inside of the assist spring were more heavily concentrated to one side, corresponding with the fracture initiation region.

Corrosive elements of sulfur, calcium, and potassium were detected from the inner surface deposits. These corrodents are known to attack alloy steel materials.

- Audit all flat ramp telescoping gangway platforms for compliance with the manufacturer’s guidelines, and take corrective actions as needed.
- Assess equipment to ensure it is not subjected to hazardous substances or other environmental factors that may cause harm to the equipment and it’s components.

- Develop, establish, and maintain a periodic, preventative, and predictive maintenance program per the manufacturer’s guidelines. Eyebolts, shackles and pins can wear from usage, and should be replaced periodically. Note: for chain replacement, verify chains match the original chain size and length.

- Develop, establish, and maintain an inspection program per the manufacturer’s guidelines for loose and damaged connections, missing and damaged hardware, proper lubrication, and spring adjustments.

- Train all maintenance employees and operators on use, care, maintenance, inspection, operation, and troubleshooting of telescoping gangway platforms using the manufacturer’s guidelines.
