## Lack of Guarding Around a Skylight Leads to Multiple Injuries

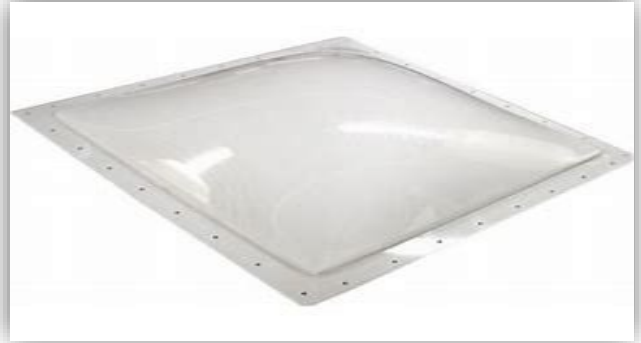
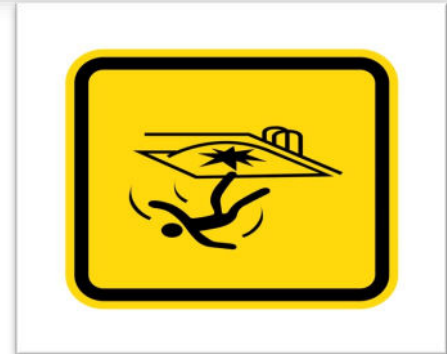
A USW member was seriously injured when he fell through an unguarded skylight. Two USW production workers were instructed by their supervisor to do roof cleanup tasks, they were specifically assigned to sweep water from a building's roof.

At some point during a work break, one worker went to use the restroom, and the other worker remained on the roof. It's unclear how the worker that stayed on the roof fell through the unguarded skylight which ultimately caused him to fall approximately three stories.

- If possible, eliminate skylights to remove the risk of falls altogether, and add lighting solutions, such as LED panels to maintain natural or efficient lighting without requiring skylights.

- Install skylight guards, screens or cages that are permanently fixed in place to prevent workers from falling through skylights that comply with OSHA and consensus standards, as well as the manufacturer's recommendations.

- Secure skylight covers and screens that can support at least twice the expected load (including workers, tools, and materials) to ensure they can handle accidental contact that comply with relevant fall protection safety standards.

- Skylights must be installed in accordance with local building codes and regulations, as well as the manufacturer's instructions.
- Install a guardrail system around skylights where feasible, ensuring it meets height and strength requirements for fall protection.
